DEMONSTRATING P&A OPERATIONAL EXPERTISE: EFFICIENT & SAFE DECOMMISSIONING IN THE NORTH SEA

**Innovative Strategies and Technical Excellence
Saved \$11.5M on a 40 Well P&A Campaign**

Project Overview

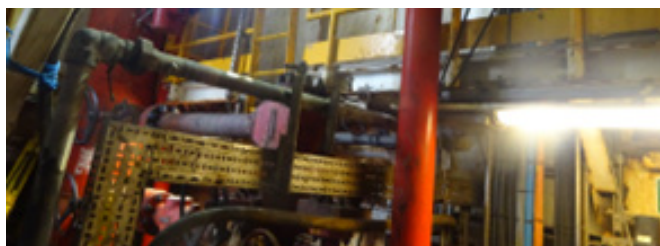
Auto Choke Valve Relocation- Design, Engineering, Fabrication & Construction. Relocated Autochoke valve on choke manifold to alleviate potential gas carry over during well control operations.
